case study

Nationwide car dealership

Leeds, West Yorkshire

Leak due to corroded fuel line

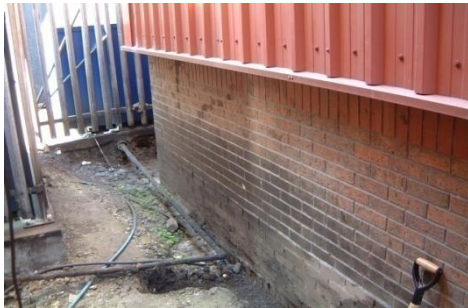
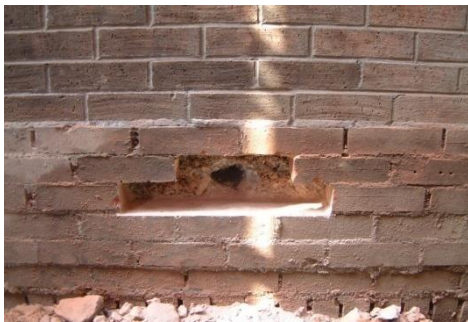
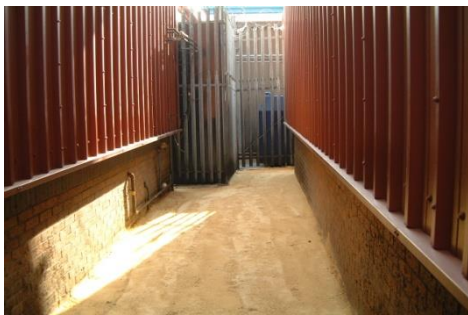
The fuel line connecting the external heating oil tank to the heating system in the workshop was badly corroded. Following a delivery of fuel the increase in pressure ruptured the fuel line externally to the building.

Due to the location of the fuel line the spill went unnoticed until the whole contents of the fuel tank had drained from the tank, resulting in gross impact of the adjacent soils and spreading of the contamination into and below the fabric of the building.

An investigation was undertaken to determine the extent of the impact and the affected soils were excavated and removed to landfill. Investigations were undertaken to assess the impact to the building fabric and beneath the floors.

The in situ treatment of the contaminated materials below the floors was undertaken using an in situ injection system.

The building fabric was cleaned down using a combination of chemical and biologically active cleaning agents.

The fuel lines were re routed and replaced with higher specification materials..
